# 10 Materials Used in the Transport of Potable Water with Special Reference to Stainless Steel and Corrosion

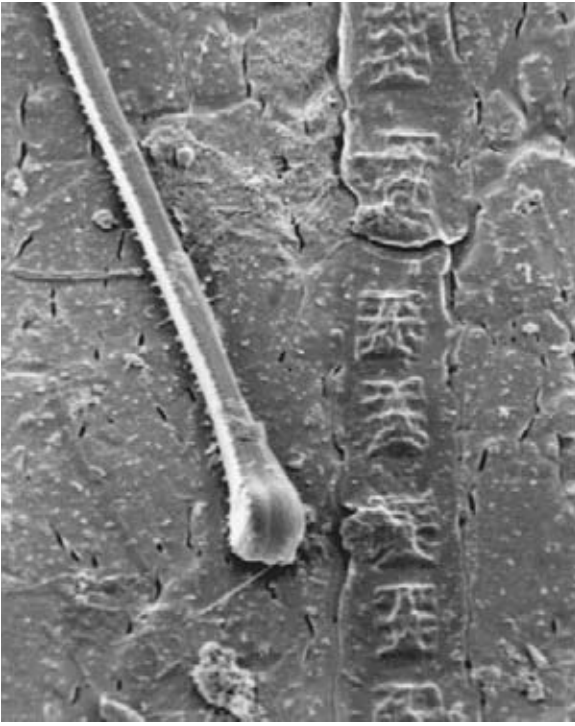
**FIGURE 10.4b** Diatom associated with surfaces in potable water.

Microalgae have been reported to affect electrochemical reactions directly. The diatom species, *Nitzschia*, has been shown to bring about a reduction in corrosion by causing cathodic polarisation.<sup>35</sup> Conversely, *Achnanthes* was found to induce cathodic depolarisation. Of cyanobacterium, two species have been implicated in the corrosion of stainless steel.<sup>32</sup> As with macroscopic algae, diatoms are known not to proliferate in potable water owing to the restriction of a light source. However, diatoms are known to become entrapped in biofilms present in potable water. The number of different species present in these biofilm is quite large [Figures 10.4(a)–(e)]. Whether diatoms have any significance in potable water is presently an area which has not been investigated.

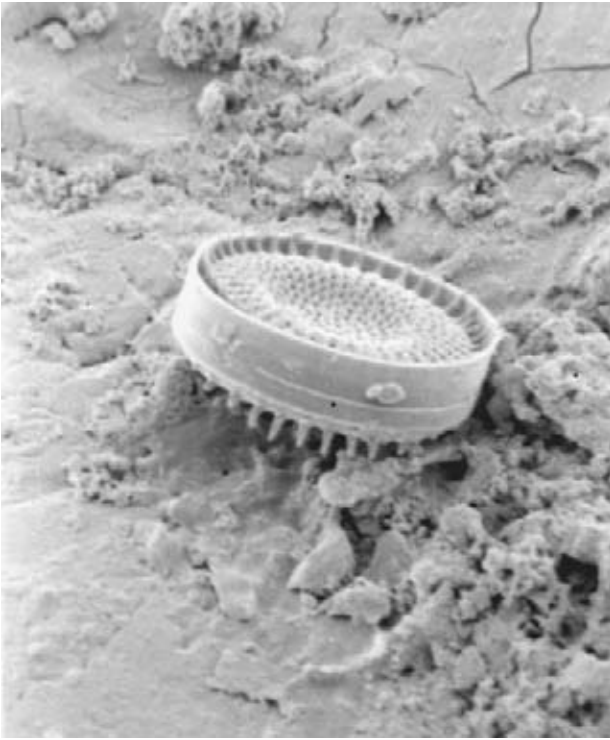
**FIGURE 10.4e** Diatom associated with surfaces in potable water.

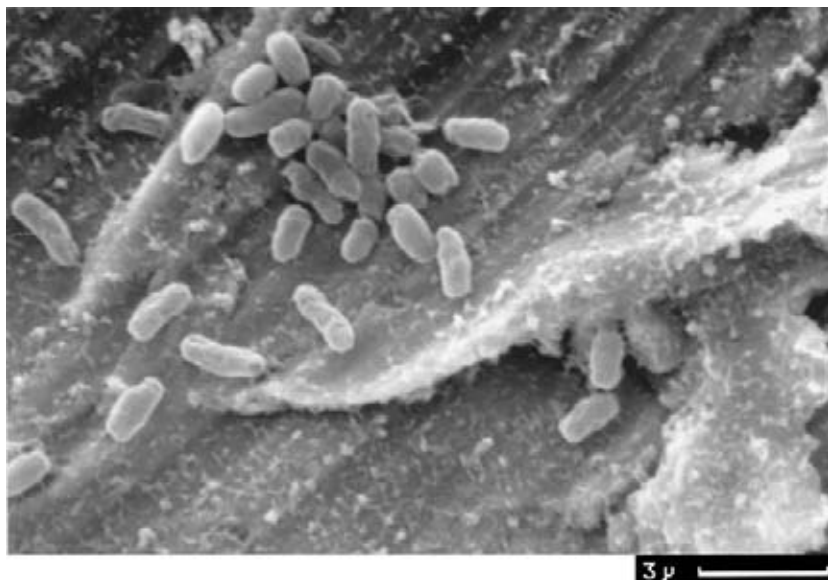
**FIGURE 10.7** Evidence of small and single colonies in potable water.
